Gas Reclaim BPR water Stagnation

The present technical bulletin contains technical information aimed to support/improve Drass equipment currently in operation.

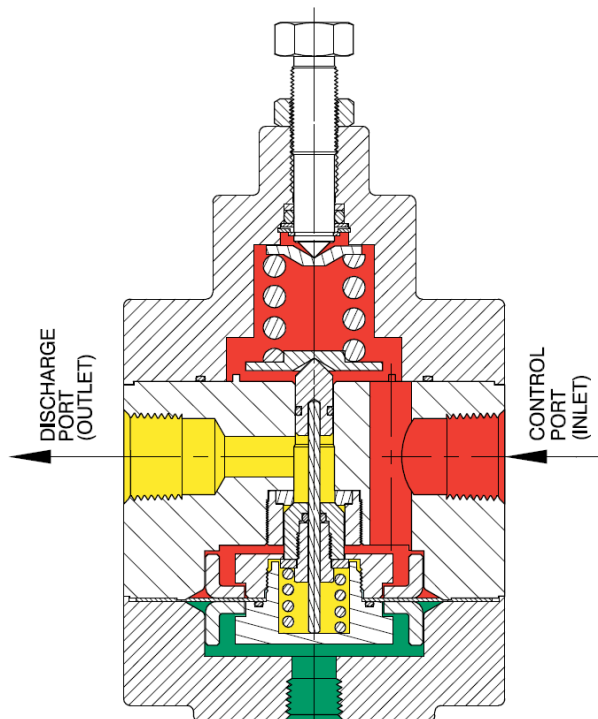
Stagnation of water inside the BPR of the Water Trap. This could happen because the BPR is installed in vertical position. The water stagnation area is highlighted in green in the below image.
